# Operation Dragon's Den

*By Lieutenant Colonel Vasili Karatzas and Sergeant First Class Alejandro Ibarra*

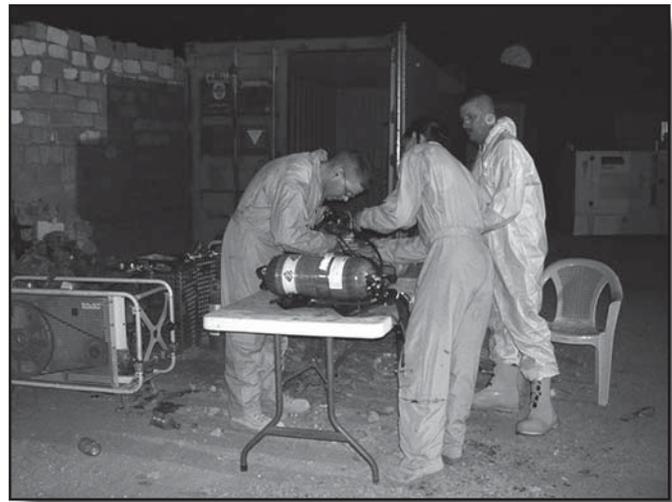
**A Soldier exiting the hot area drops off his self-contained breathing apparatus for refitting and refilling.**

Safety would be one of the keys to a successful mission. Baseline vital signs of all team members would be checked before they entered and after they exited the toxic area. The wear and function of gear would be checked by a full-time safety officer before team members were allowed to enter the contaminated area. A buddy system would be employed; at no time would anyone be allowed to be alone in the toxic area. While downrange, the safety officer and the officer in charge (OIC), noncommissioned officer in charge (NCOIC), or operations NCOIC would continuously monitor team members. Corrections would be made as personnel worked. Anyone who committed a safety violation or premature alarm activation would immediately be removed and refitted. Upon exiting the contaminated area, team members would be decontaminated and medically checked. They would drop off their equipment for refitting, and their tanks would be refilled. Team members would be allowed to rest for about an hour before reentry.

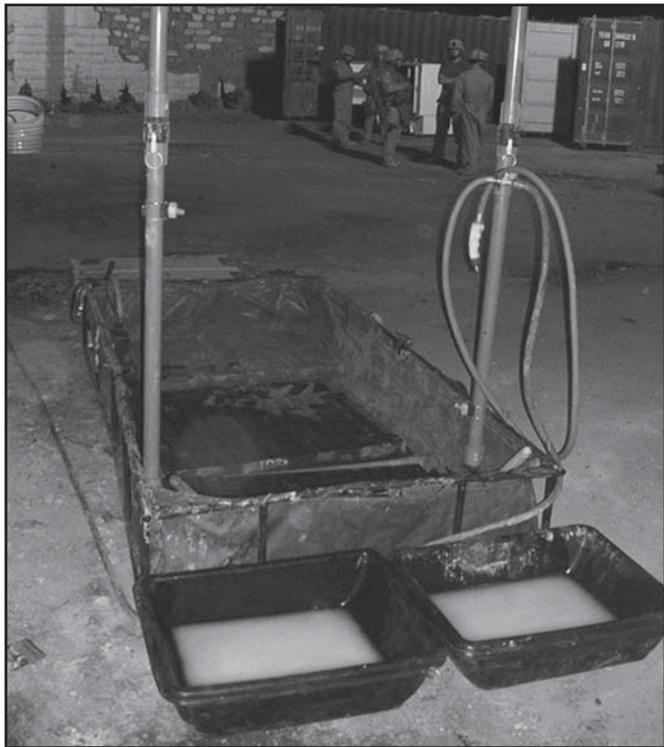
**Decontamination shower used by personnel exiting the hot area**

- A thirty-kilowatt generator, which provided power.
- A toxic industrial chemical protection and detection equipment (TICPDE) shower system, used for decontamination.

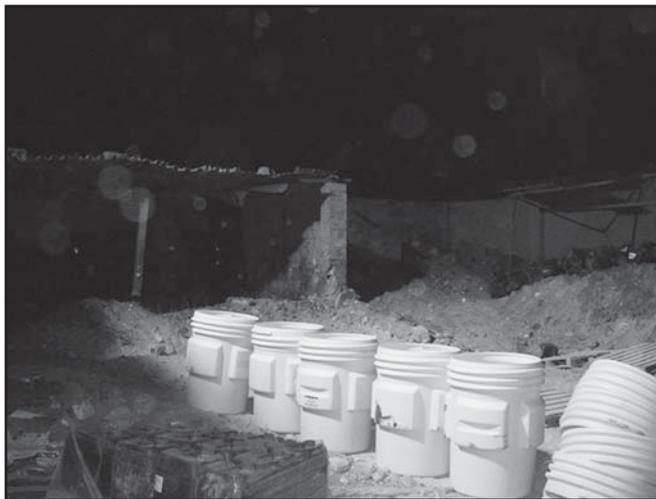
**Overpack containers ready to be filled**

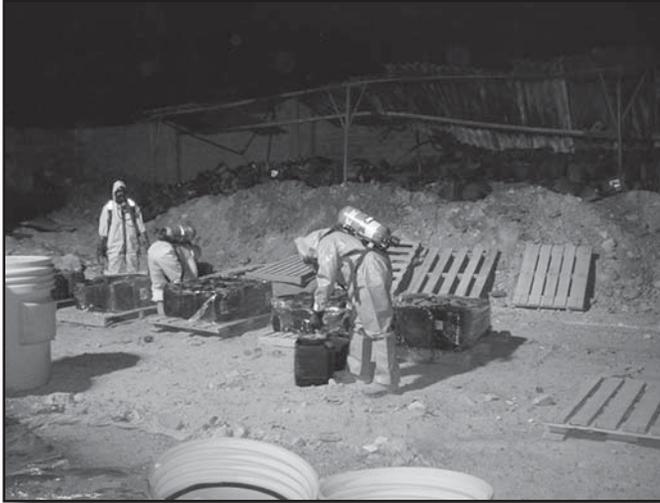
**CBRN personnel pack nonleaking containers of nitric acid on pallets for movement to Camp Fallujah.**

An environmental team conducted quality control checks on the packing and loading operations, ensuring that the hazmat was safe for transportation. Another environmental specialist received the hazmat and supervised marking, labeling, and turn-in to the hazmat yard. Containers that had been damaged
