EFFECTING A MAJOR ROAD REPAIR IN BAGHDAD

*By Lieutenant Colonel Keith A. Landry,
Major Glen T. Adams, and Captain Steven M.
Brown*

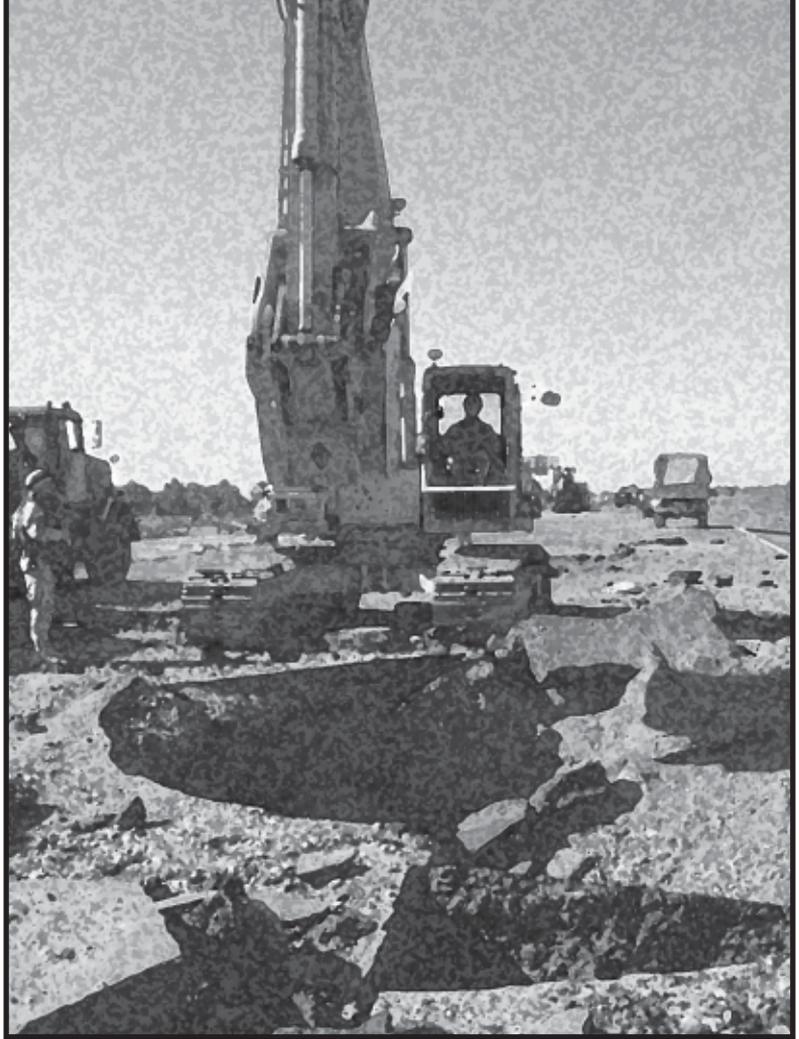
- **Phase I** consisted of mobilizing and deploying horizontal engineer assets to clear blast debris from the crater and repair the road base (see photo on page 15). Required equipment included a vibratory roller, a front-end loader, a hydraulic excavator (HYEX), a bulldozer, a Bobcat®, two M916 tractors with M870 trailers carrying Texas "T" concrete barriers (which served as vehicle-borne improvised explosive device [VBIED] blast shields), and five 20-ton dump trucks. Two of the trucks were loaded with fill, while the remaining trucks carried crushed limestone. To minimize the fill required to repair the subbase, blast debris from the craters was used for backfill. Clean fill was deposited on top of the blast debris in layers and compacted. An 8-inch lift of crushed limestone was used as the base for the 10-inch-thick reinforced concrete wearing surface.

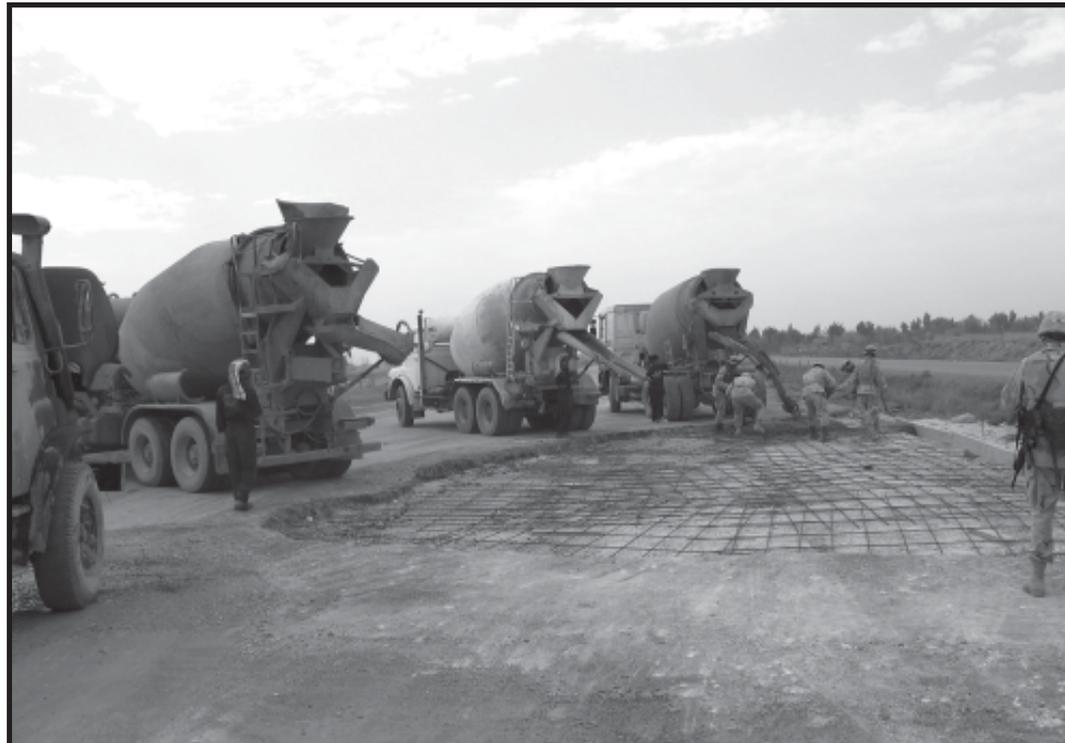
A local contractor provided the concrete that Task Force Black Diamonds placed to repair Crater B.

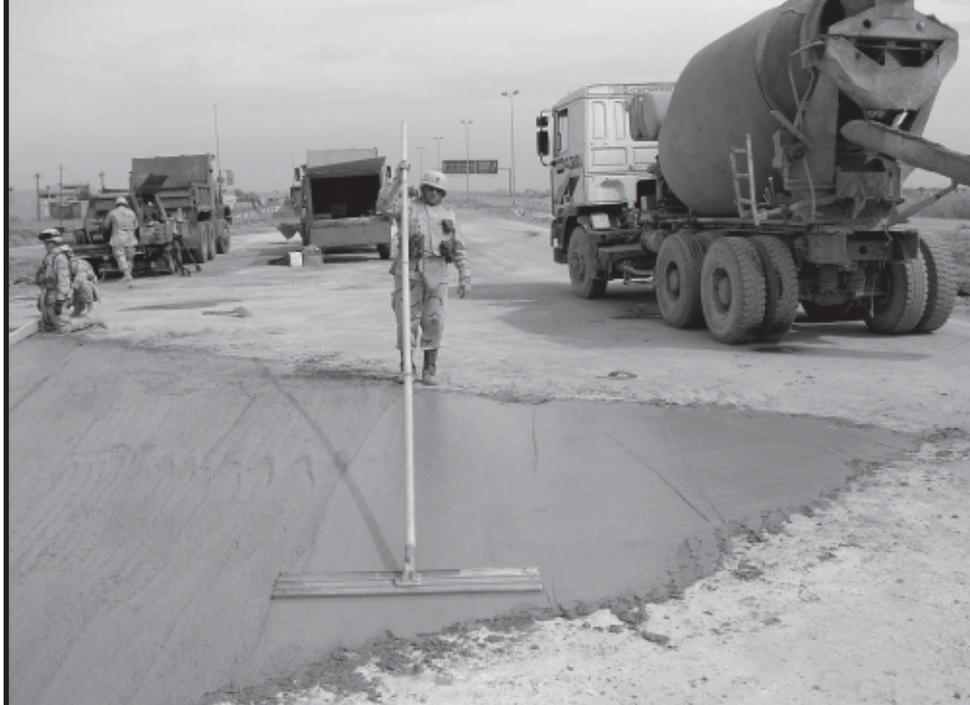
A Task Force Black Diamonds Soldier uses a float to finish the repair of a crater after the vibrating and screeding process.
