# Assured Mobility

By Major Craig Wertheim

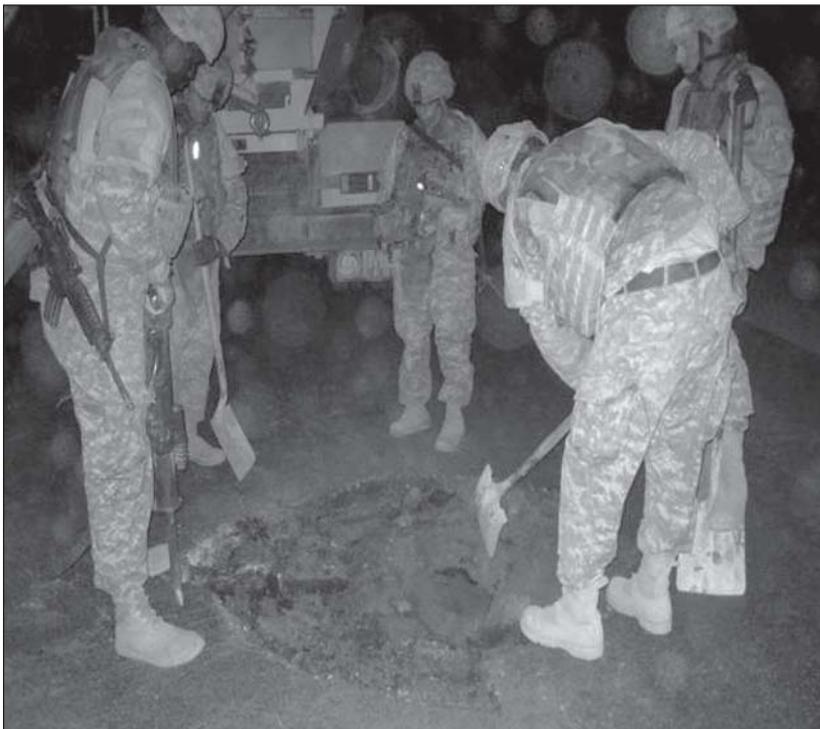
**Soldiers from the 92d Engineer Battalion repair a blast hole formed by an IED detonation.**

The second step to assured mobility was to deal with the blast holes formed when an IED detonated on a road. These holes ranged from a small indentation up to a crater that could swallow a truck. To combat these holes, the brigade used construction assets from its construction and combat engineer battalions. This operation took not only engineers but also a combined arms team to make it a success. Frequently, the brigade sent out reconnaissance teams to identify and inventory new holes throughout the area of operations, and this data was made available to all units that crossed the area. It was important to inventory these obstacles to speed repair operations and prevent future IED attacks.

Once the engineers performing the work identified which holes would be filled on a mission, the brigade contacted the brigade combat teams (BCT) that owned the battlespace to coordinate security for the operation. Then the mission was confirmed, supplies were ordered, and the mission was executed. On a given mission the team could fill three to eight holes, depending on their size. The final job for the team was to mark each hole with a distinctive number and symbol. This allowed identification by friendly forces and helped track whether the hole was ever used again by anti-Iraqi forces (AIF). Security was needed to observe the blast holes to ensure that AIF did not emplace another IED in the hole just filled in. When the holes were repaired, the

road was ready for traffic to resume. The 411th filled more than 600 blast holes along the corps MSR during its deployment.

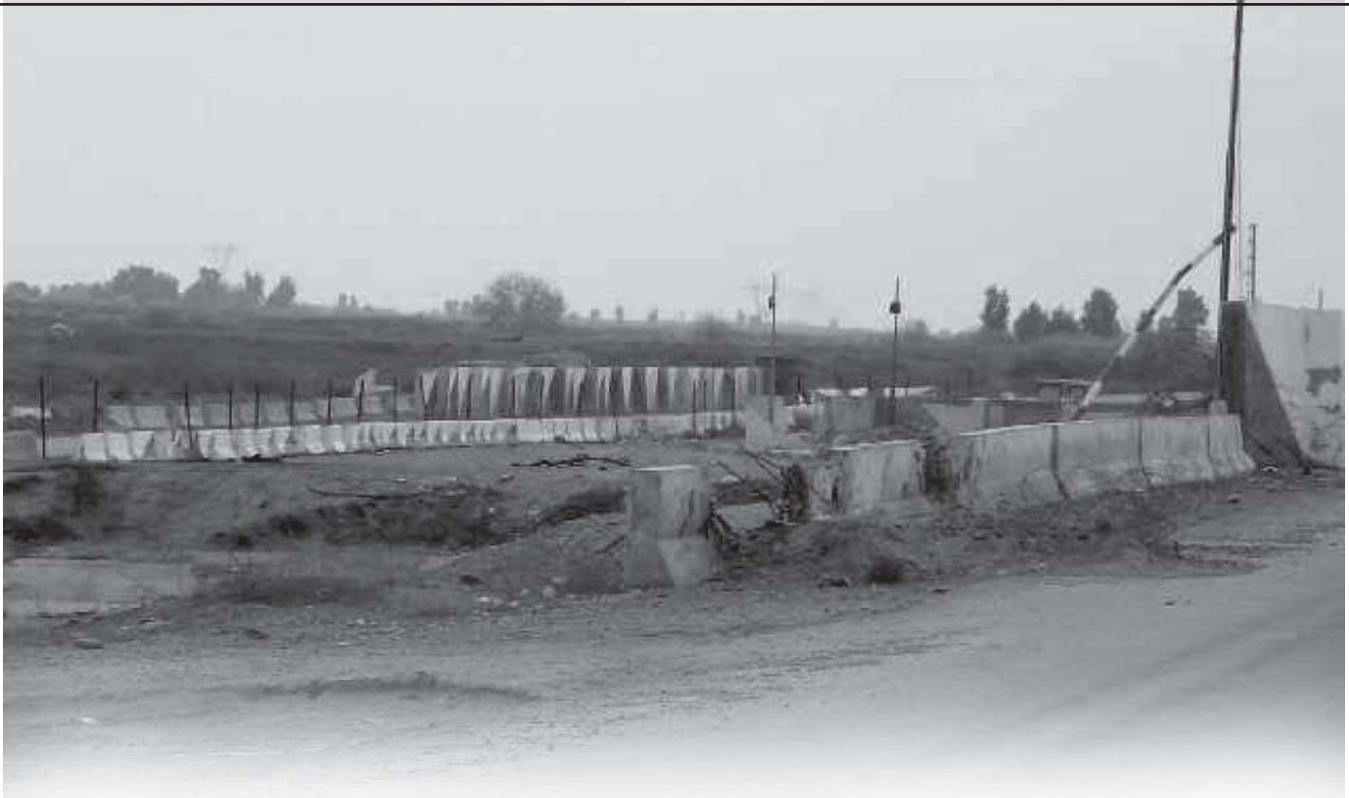
**Vegetation and debris are cleared from the median and shoulders of the MSR as part of route sanitation.**

The third step toward assured mobility was route sanitation, which consists of clearing vegetation and debris from the median and shoulders of the MSR. In Iraq, where IEDs are placed in every imaginable shrub or piece of trash, route sanitation is essential to keeping the MSR open. It was left to the route clearance battalion to decide when and where

to perform this mission. Clearing the MSR of vegetation and debris disrupts the enemy's ability to emplace IEDs close to where coalition and civilian vehicles travel. It also inhibits concealed movement by AIF, diminishes their ability to set up traps, and forces them to place their IEDs farther back from the road. This standoff increases the survivability of coalition forces. Route sanitation is a never-ending battle in Iraq. The brigade usually ran multiple sanitation missions each week.

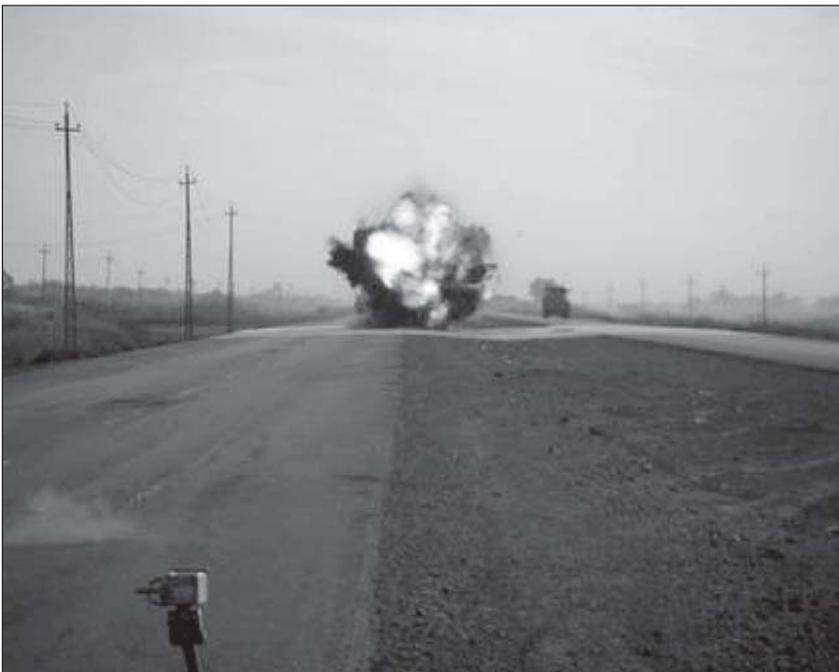
**After finding an IED during one of its missions, the route clearance team blows it in place.**

The first step in this main effort was route clearance. Planning for it started at the intelligence section, which compiled and analyzed all of the significant events from the previous weeks that occurred on the routes. The assured mobility cell then derived targeting recommendations for the brigade's route clearance battalion. Based on the slate of targeting recommendations, the route clearance battalion produced schedules that the companies used to perform their route clearance missions to force open the MSRs in support of coalition forces and the Iraqi people. During these long and dangerous missions, the engineers looked for improvised explosive devices (IEDs). The route clearance missions took up a good part of the day on the road. The Soldiers were
